ROOT CUTTER

General Description

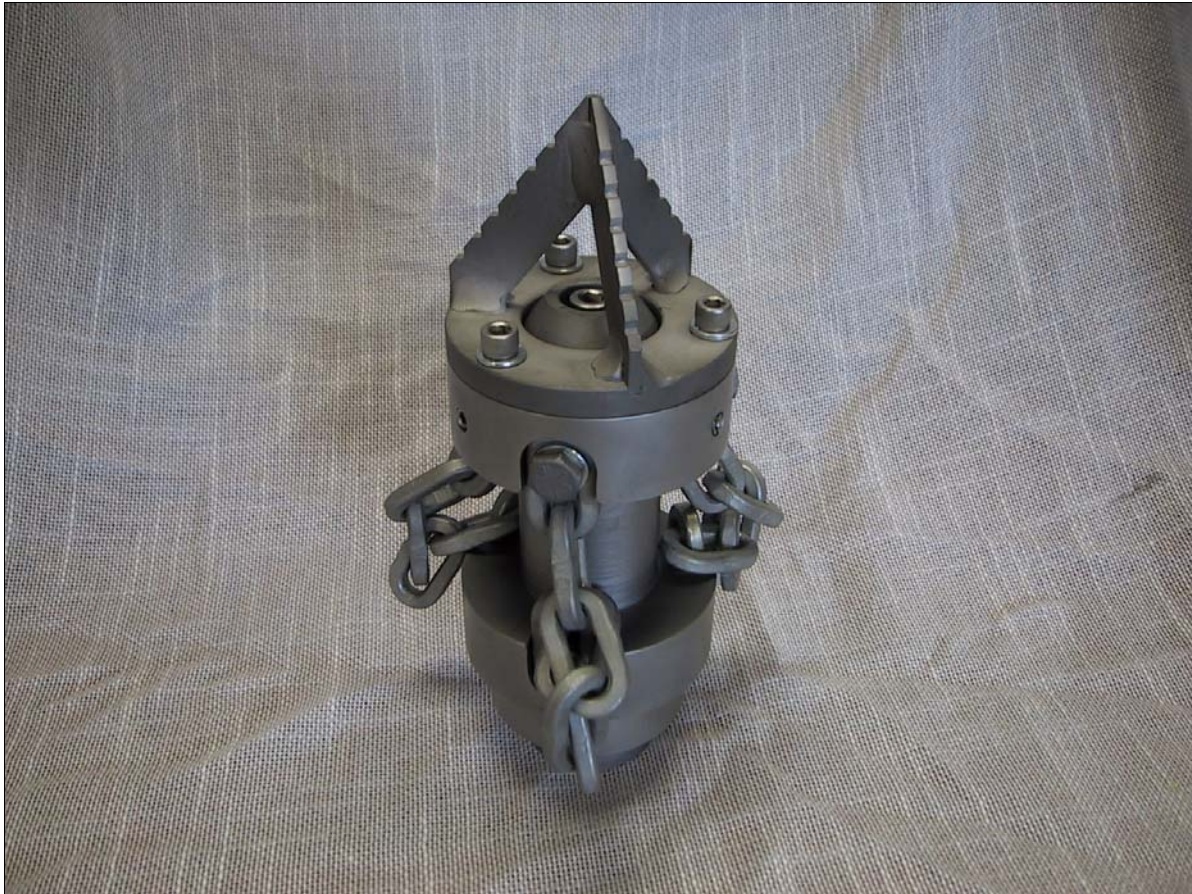
This hydraulic root cutter is used on a power flusher to provide cutting and chain flail cleaning abilities. It is constructed from 4140 Hardened steel with replaceable jets, and comes complete with 6" and 8" Centralizers.
